**Draft Report  
Project No. 60251**

**Volume 1 of 5  
Remedial Investigation Report  
ACS NPL Site  
Griffith, Indiana**

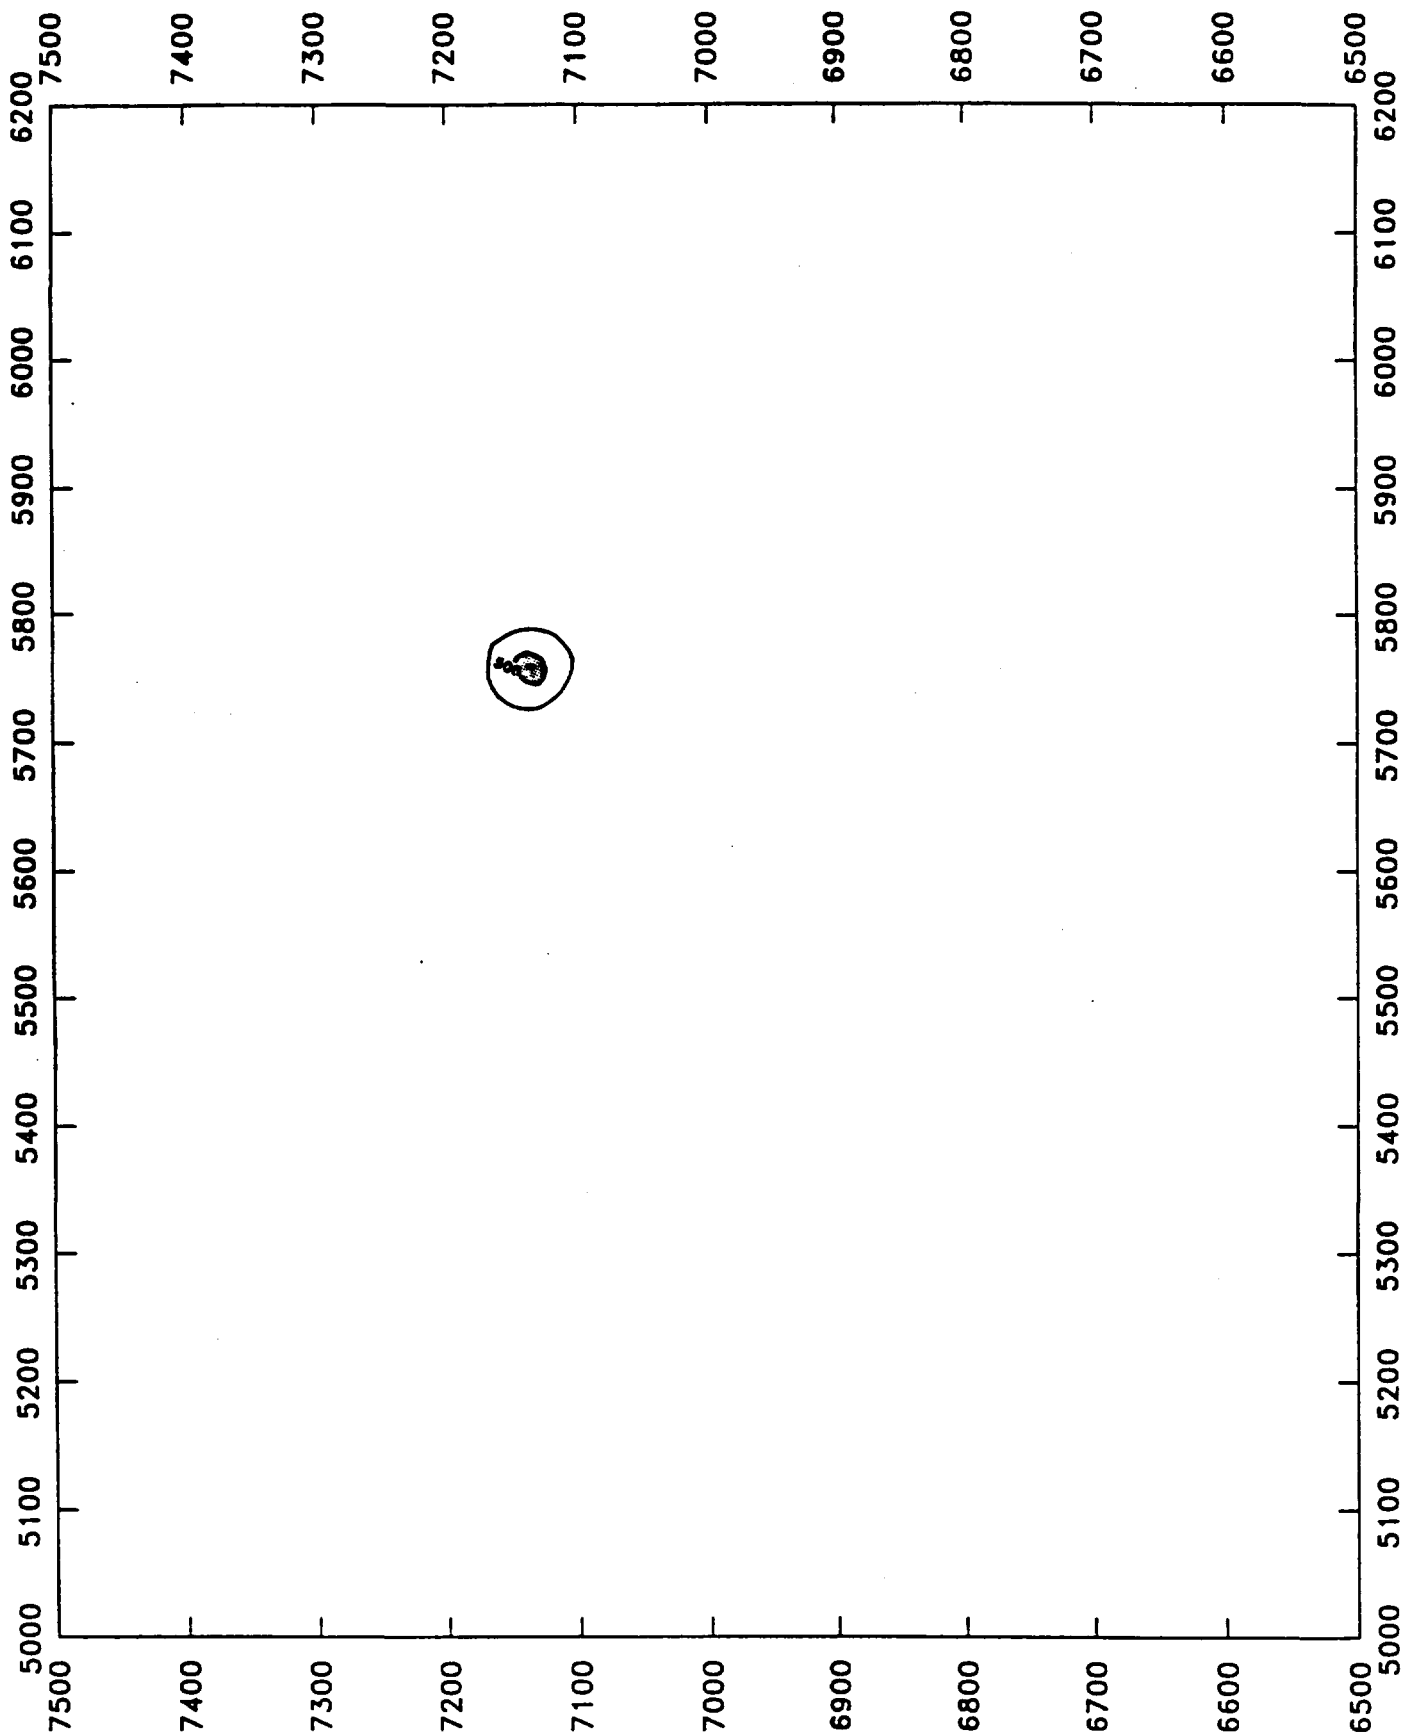
Figure 5-7a      Approximate Extent of Total PCB Containing Wastes ( $> 1$  ppm, shaded  $> 50$  ppm), On-Site Areas (1-3 feet below surface)

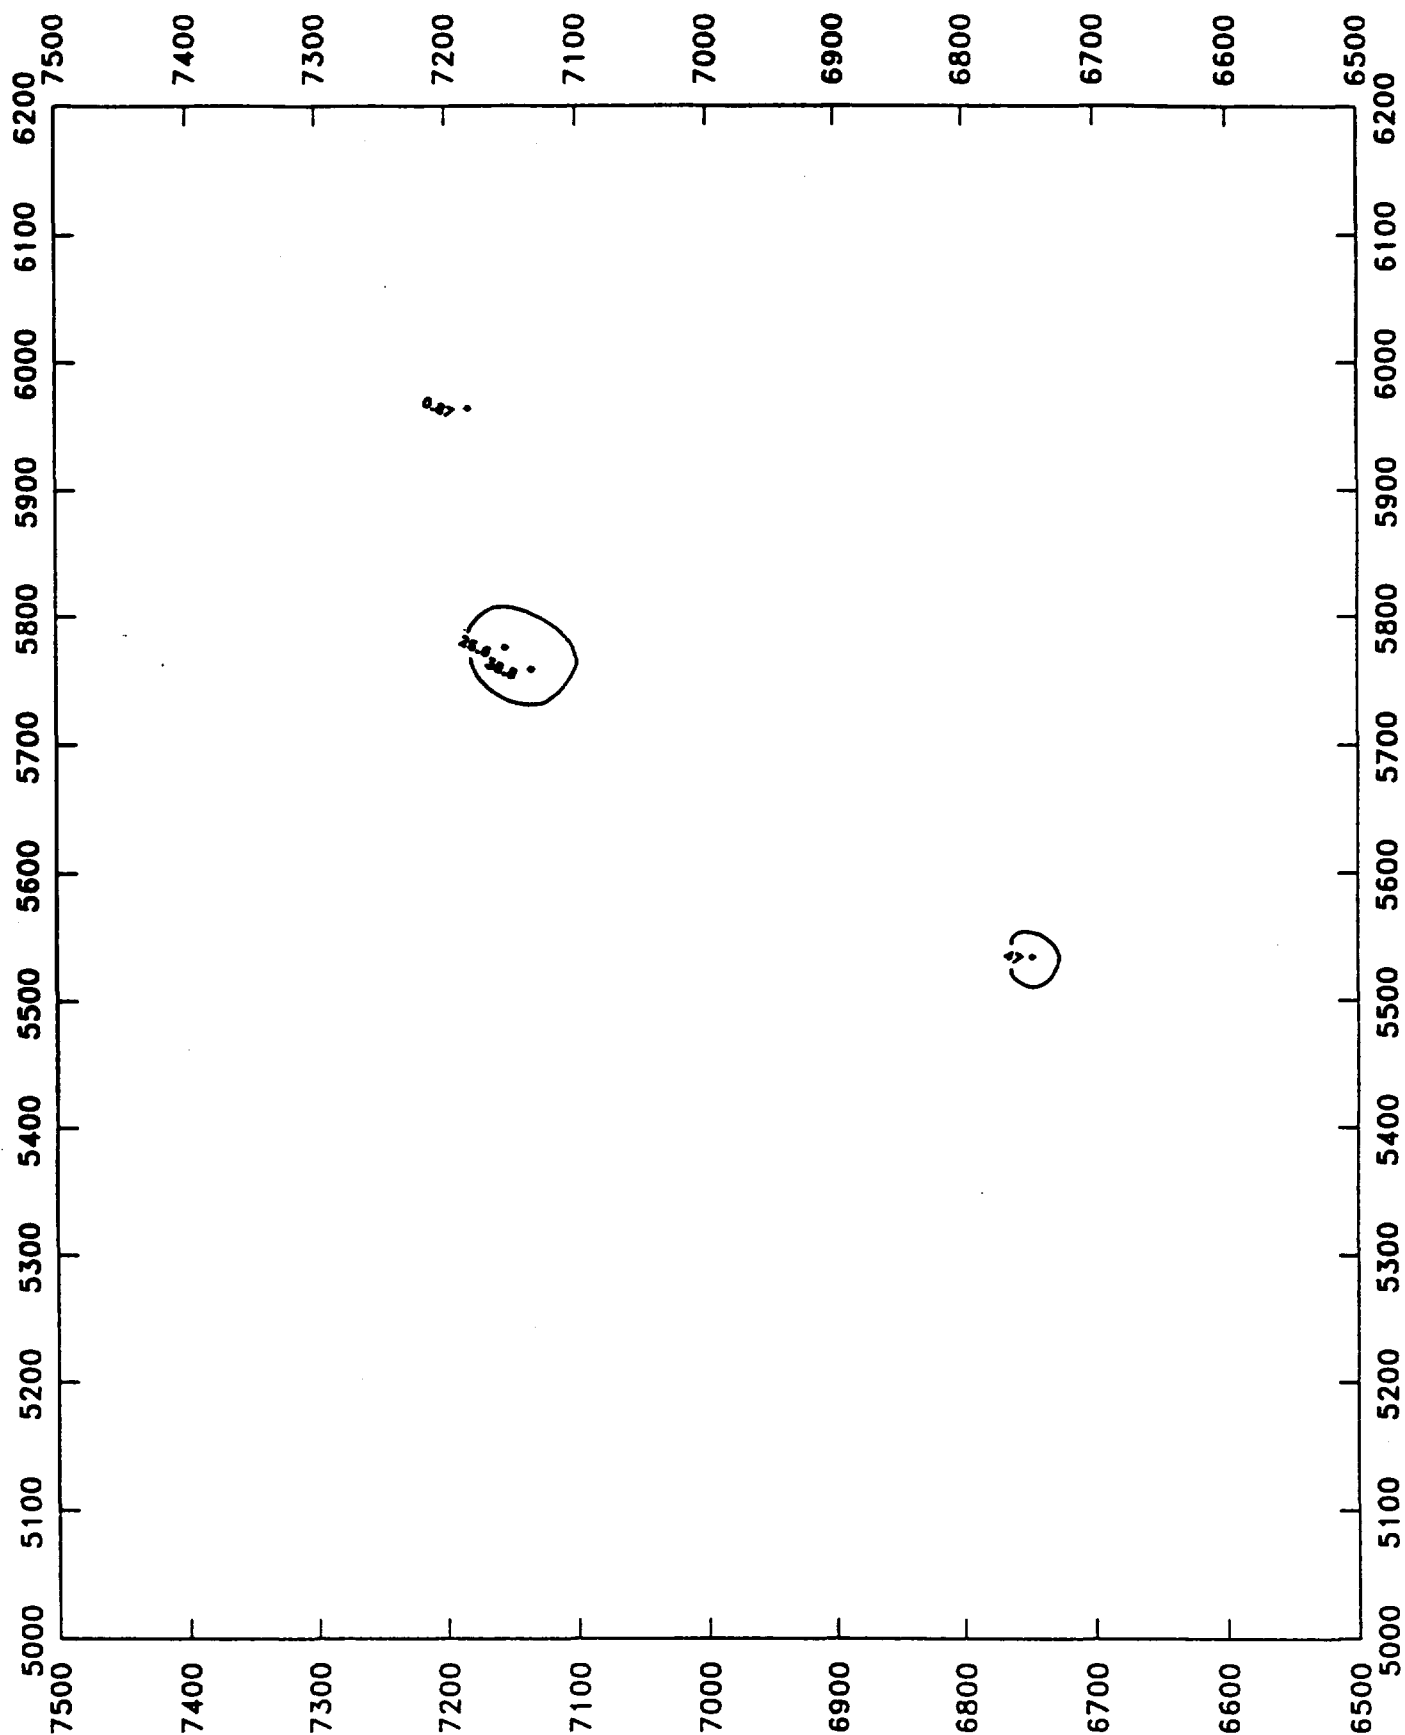
Figure 5-7b      Approximate Extent of Total PCB Containing Wastes ( $> 1$  ppm, shaded  $> 50$  ppm), On-Site Areas (3-6 feet below surface)

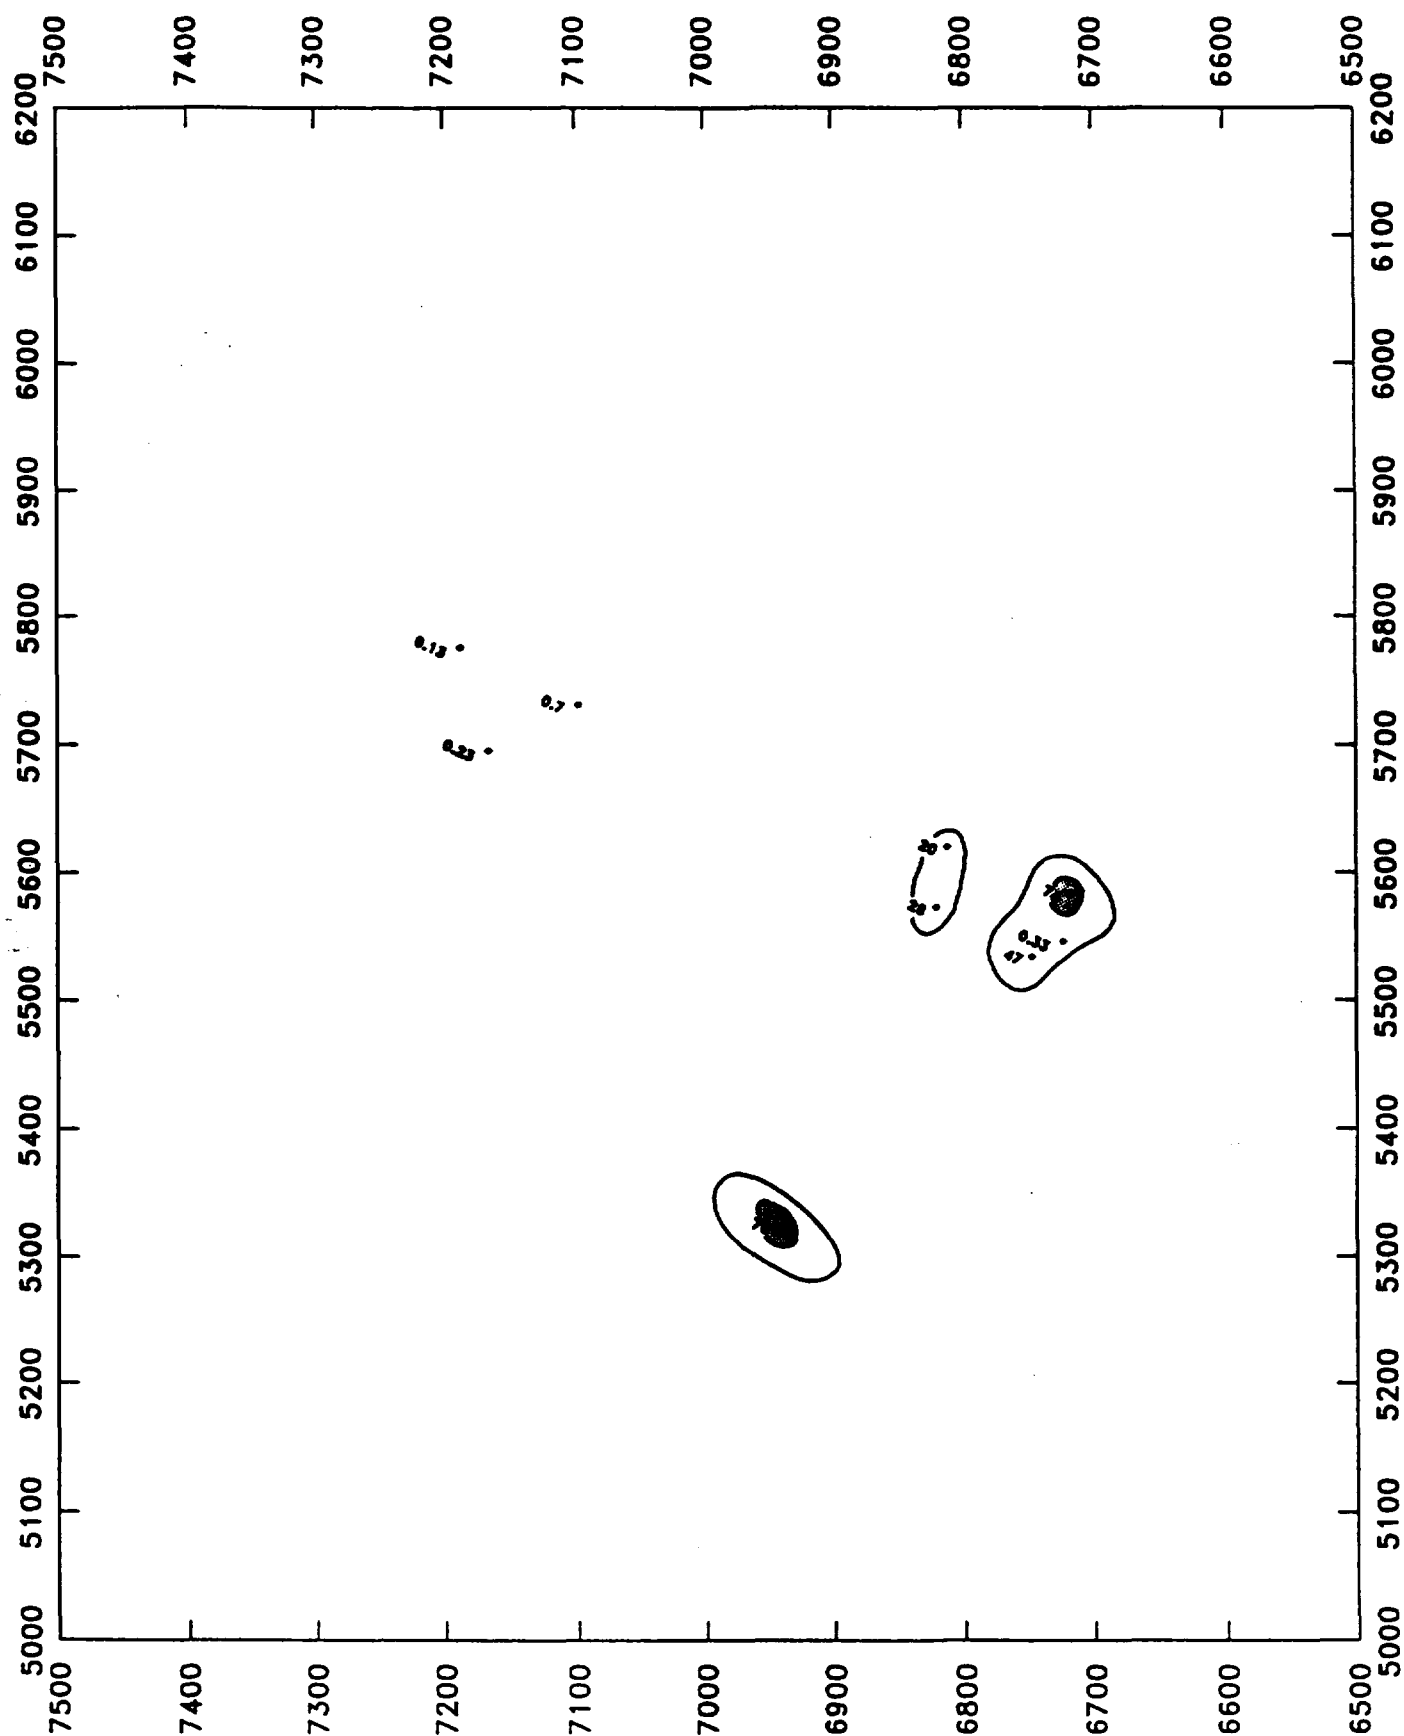
Figure 5-7c      Approximate Extent of Total PCB Containing Wastes (> 1 ppm, shaded > 50 ppm), On-Site Areas (6-8 feet below surface)

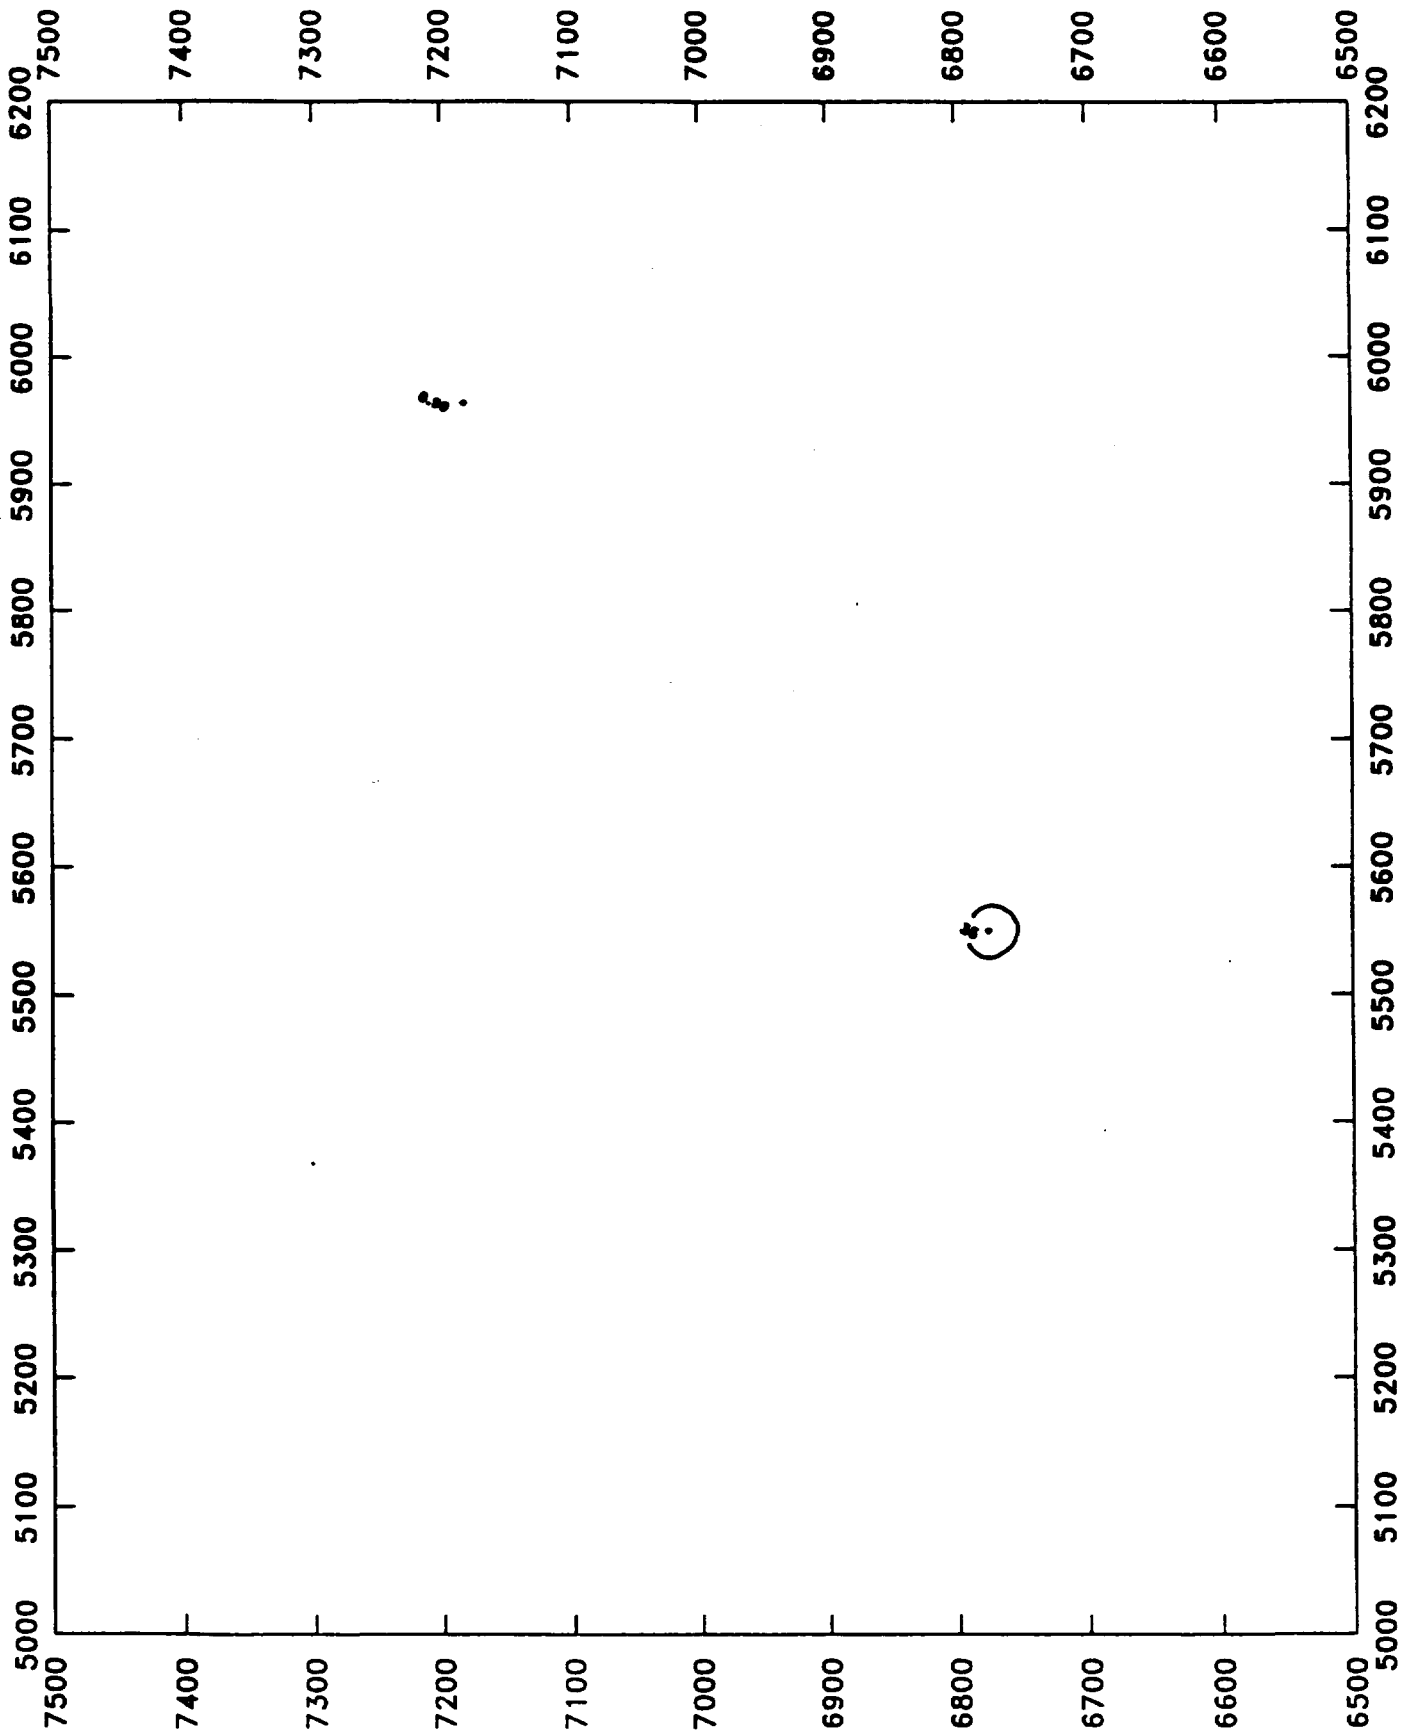
Figure 5-7d      Approximate Extent of Total PCB Containing Wastes (> 1 ppm, shaded > 50 ppm), On-Site Areas (8-12 feet below surface)

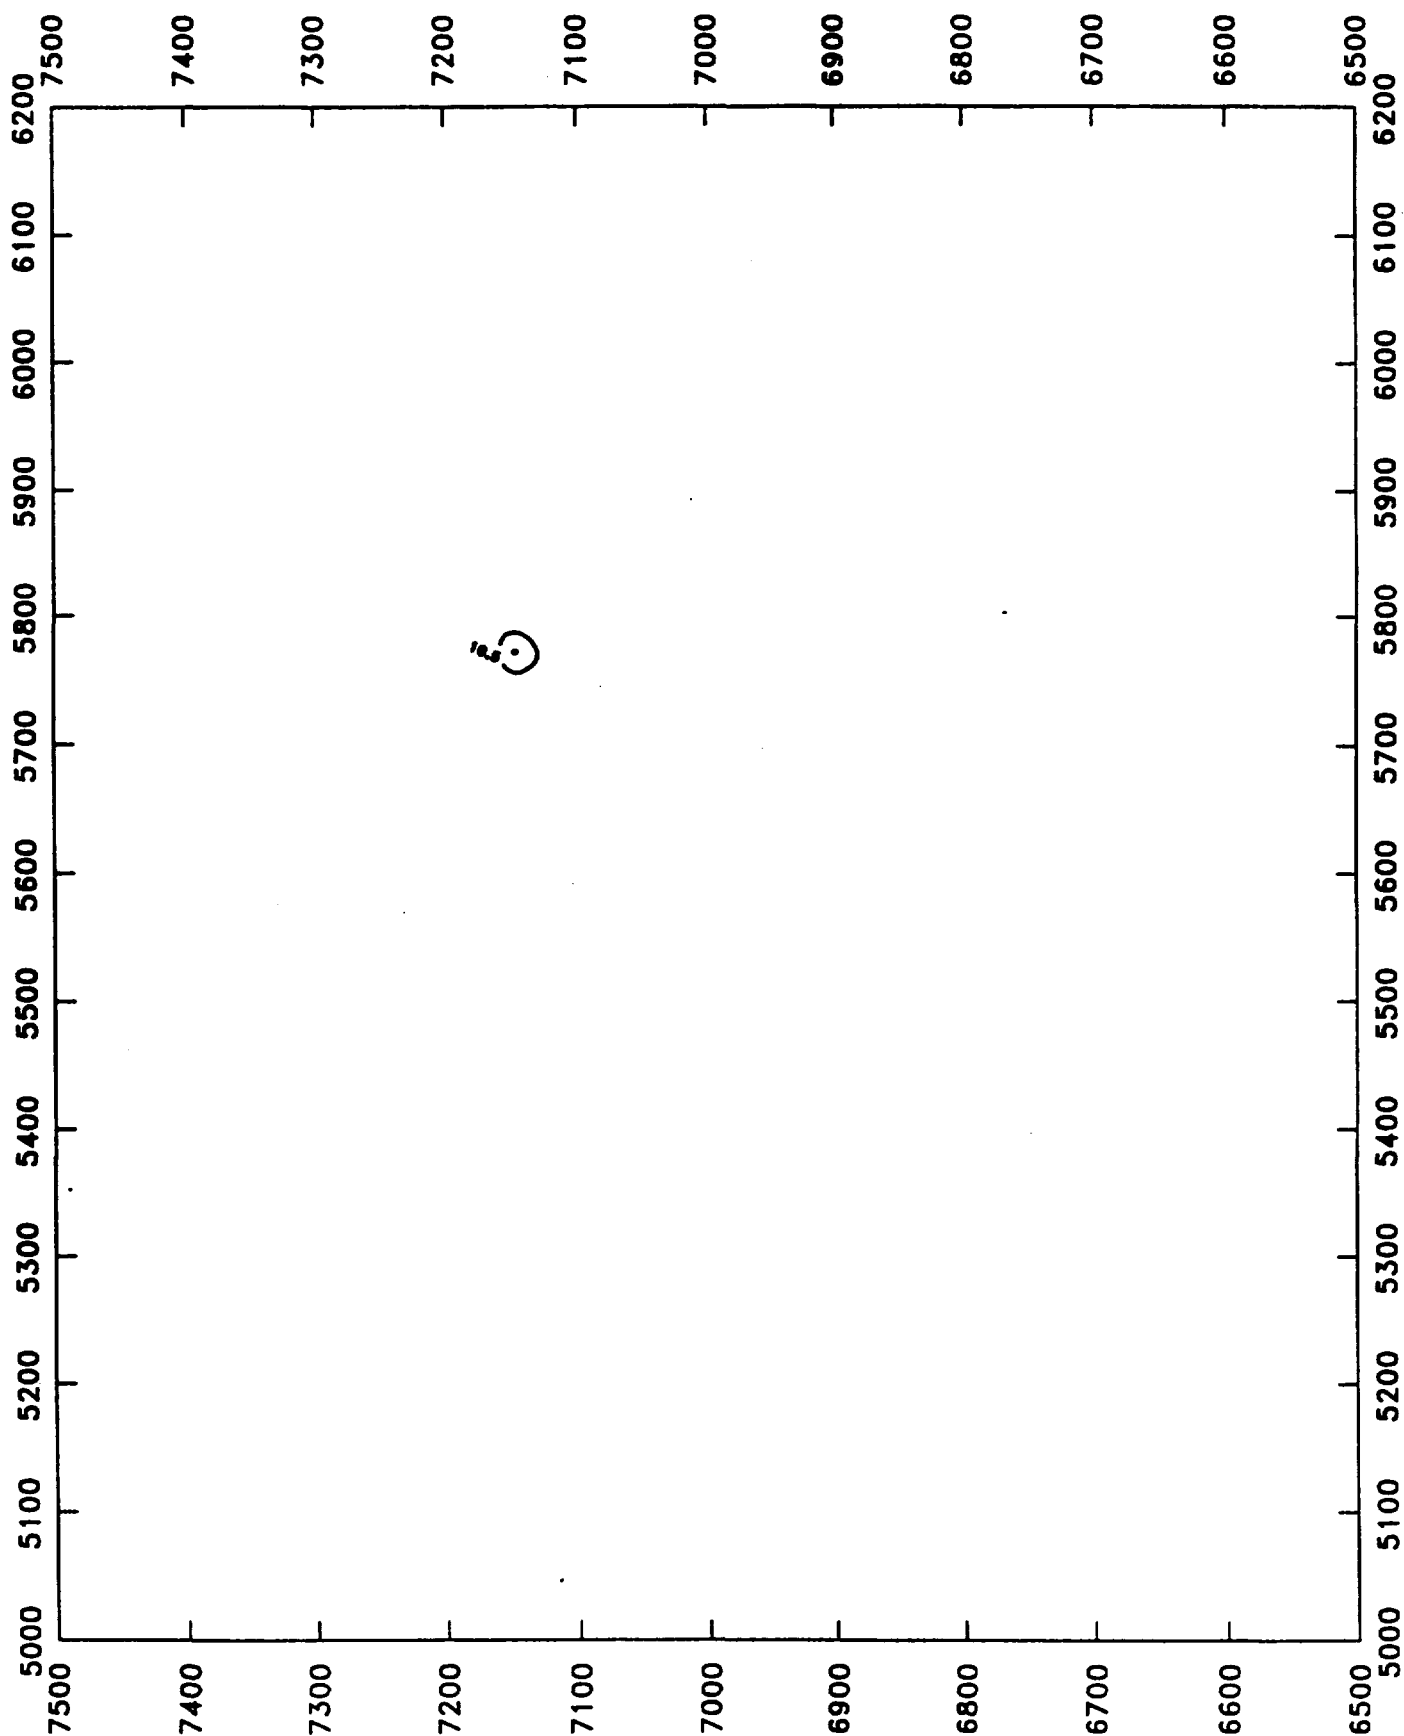
Figure 5-7e Approximate Extent of Total PCB Containing Wastes (> 1 ppm, shaded > 50 ppm), On-Site Areas (12-17 feet below surface)

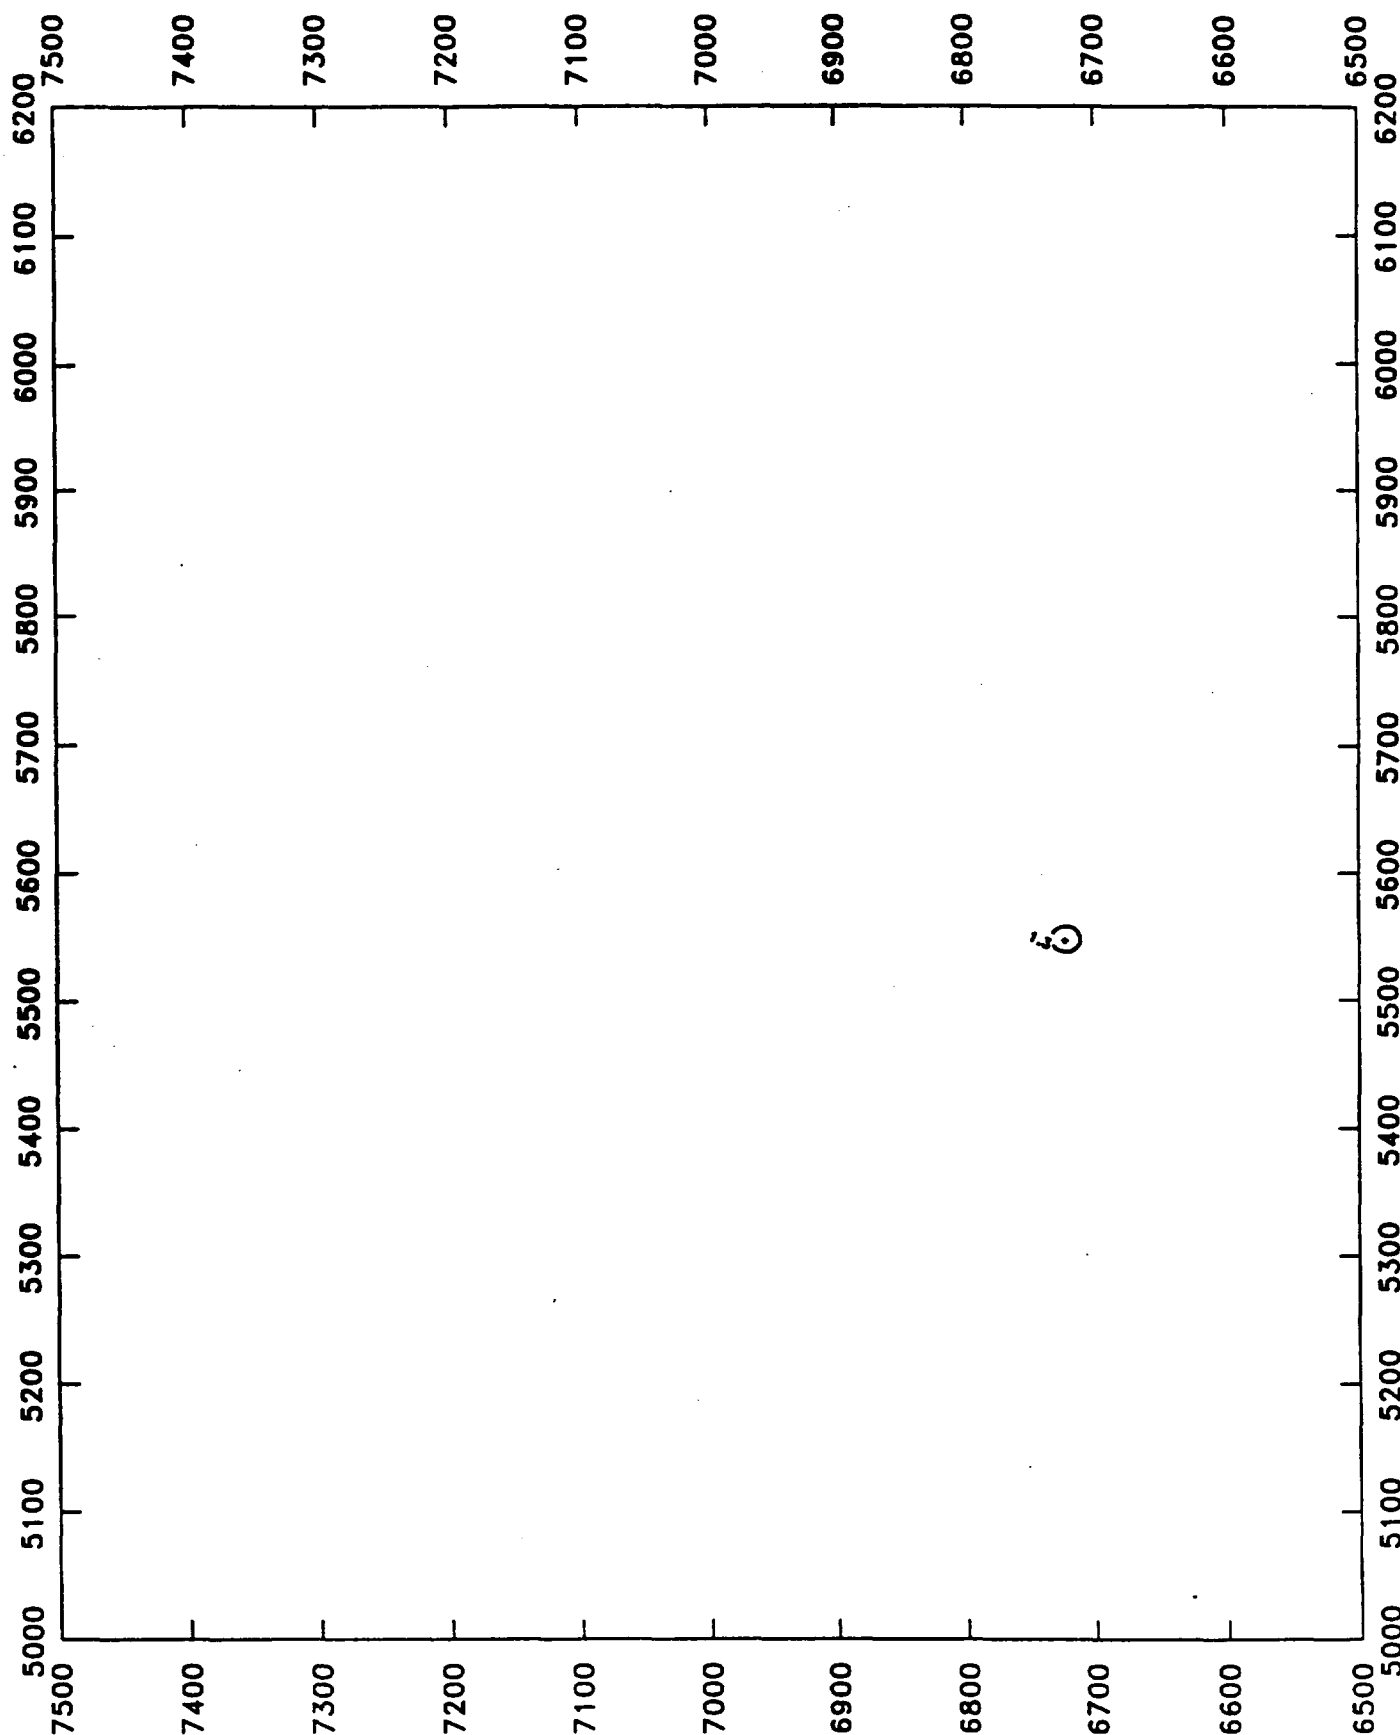
**Figure 5-7f**      **Approximate Extent of Total PCB Containing Wastes (> 1 ppm, shaded >50 ppm), On-Site Areas (17-20 feet below surface)**

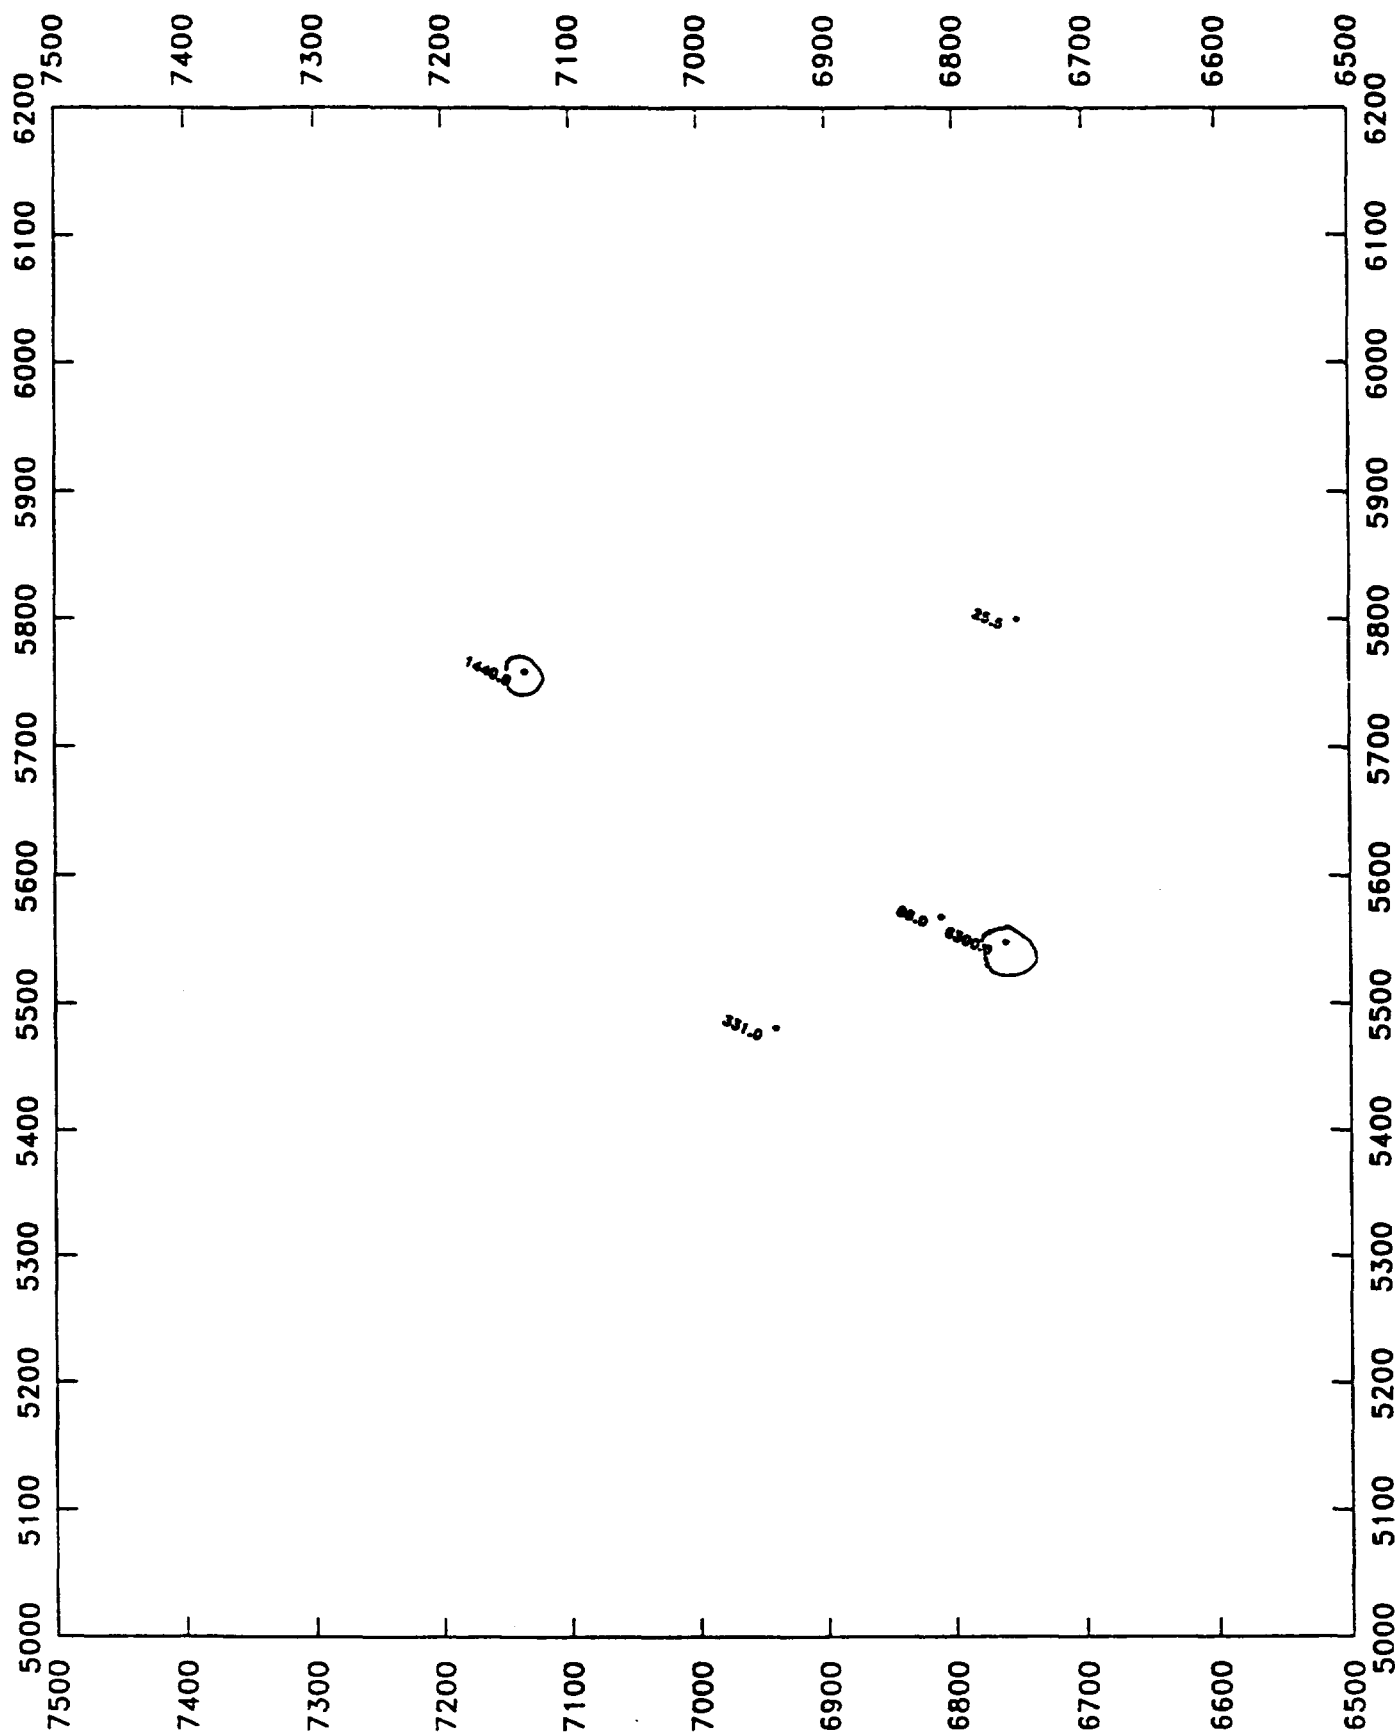
Figure 5-8a Approximate Extent of Lead Containing Wastes (> 500 ppm), On-Site Areas (1-4 feet below surface). Posted Values are in ppm (mg/kg).

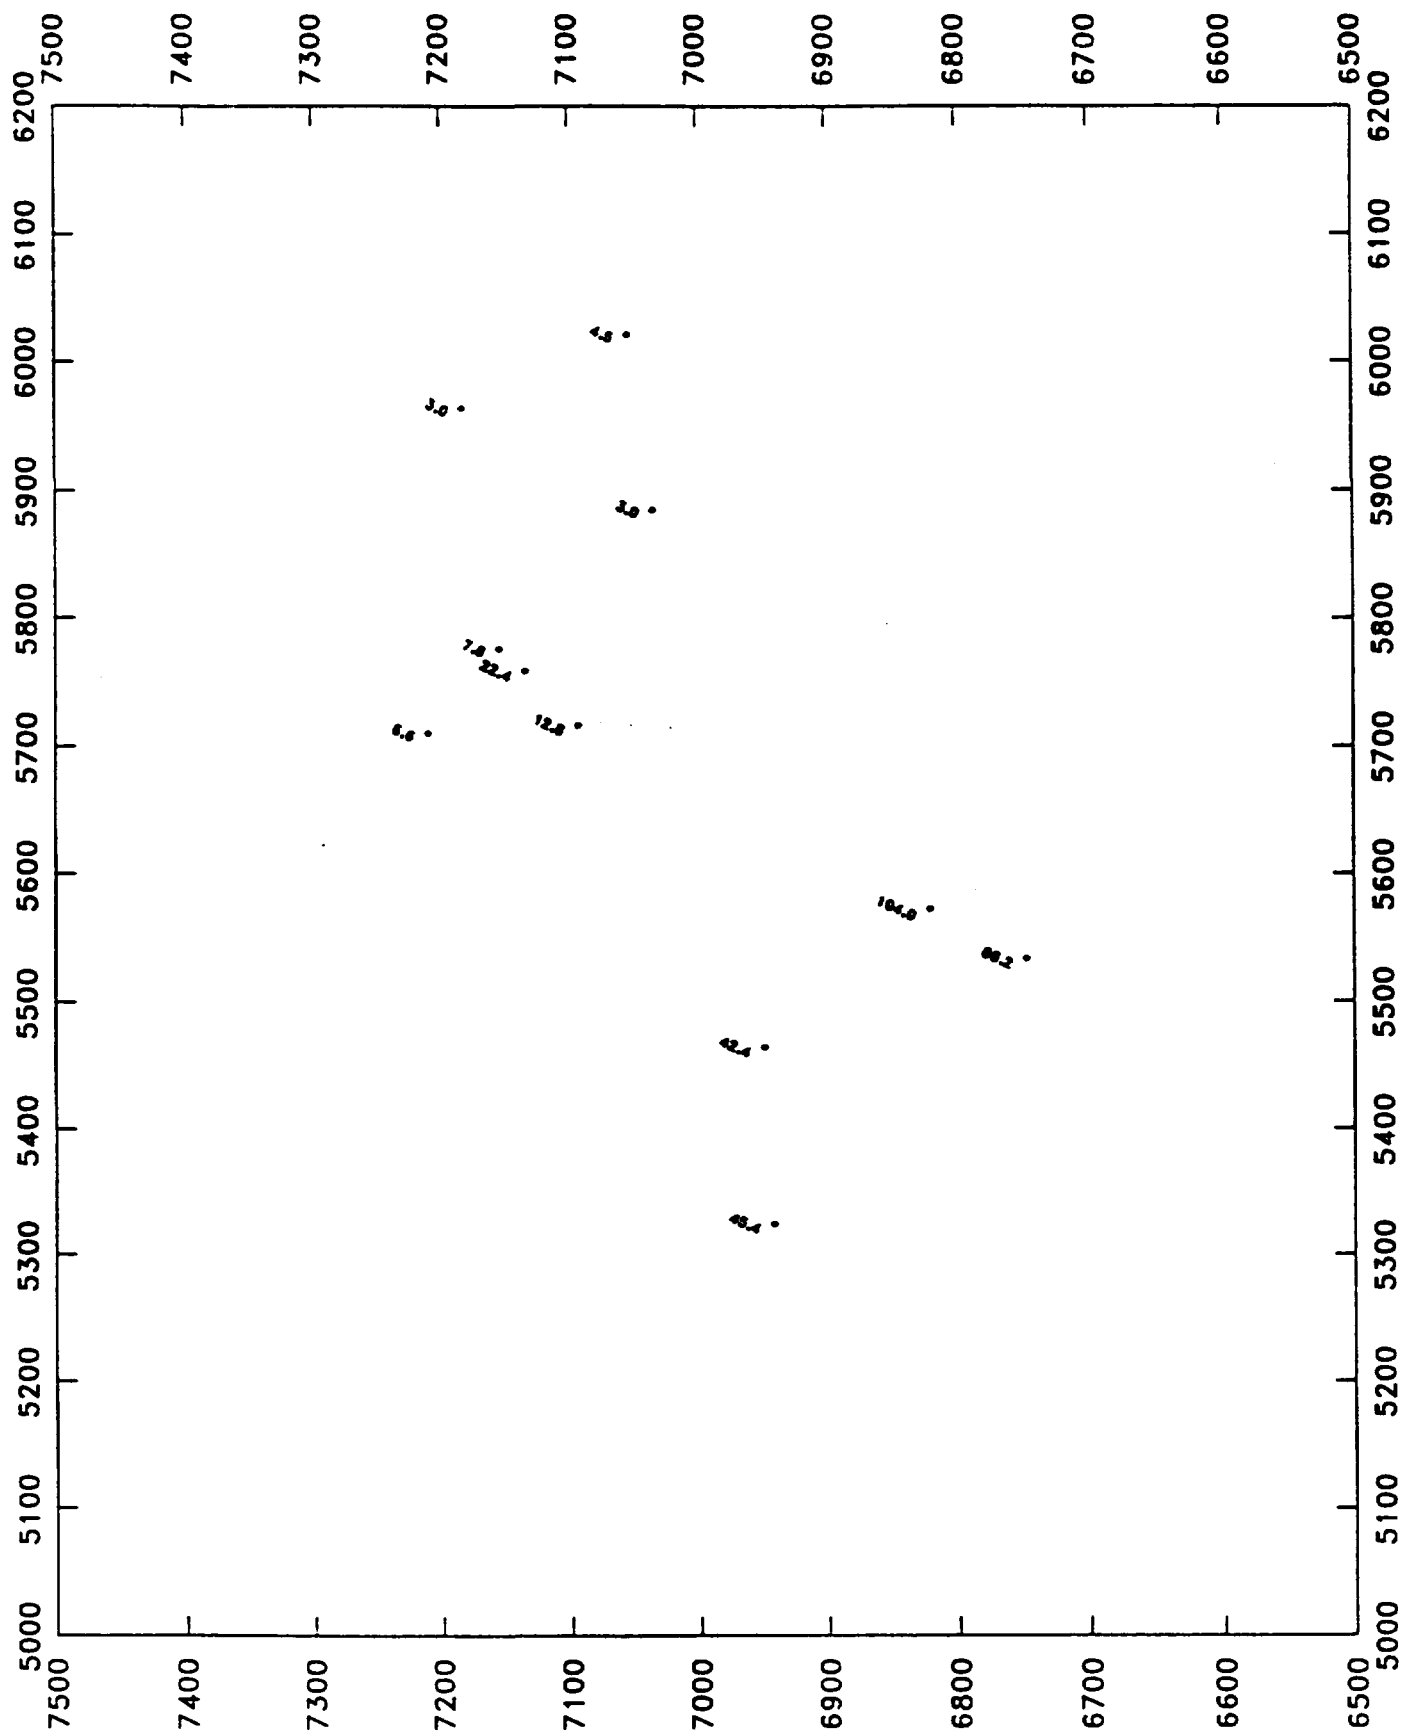
Figure 5-8b Approximate Extent of Lead Containing Wastes (> 500 ppm), On-Site Areas (4-7 feet below surface). Posted Values are in ppm (mg/kg).

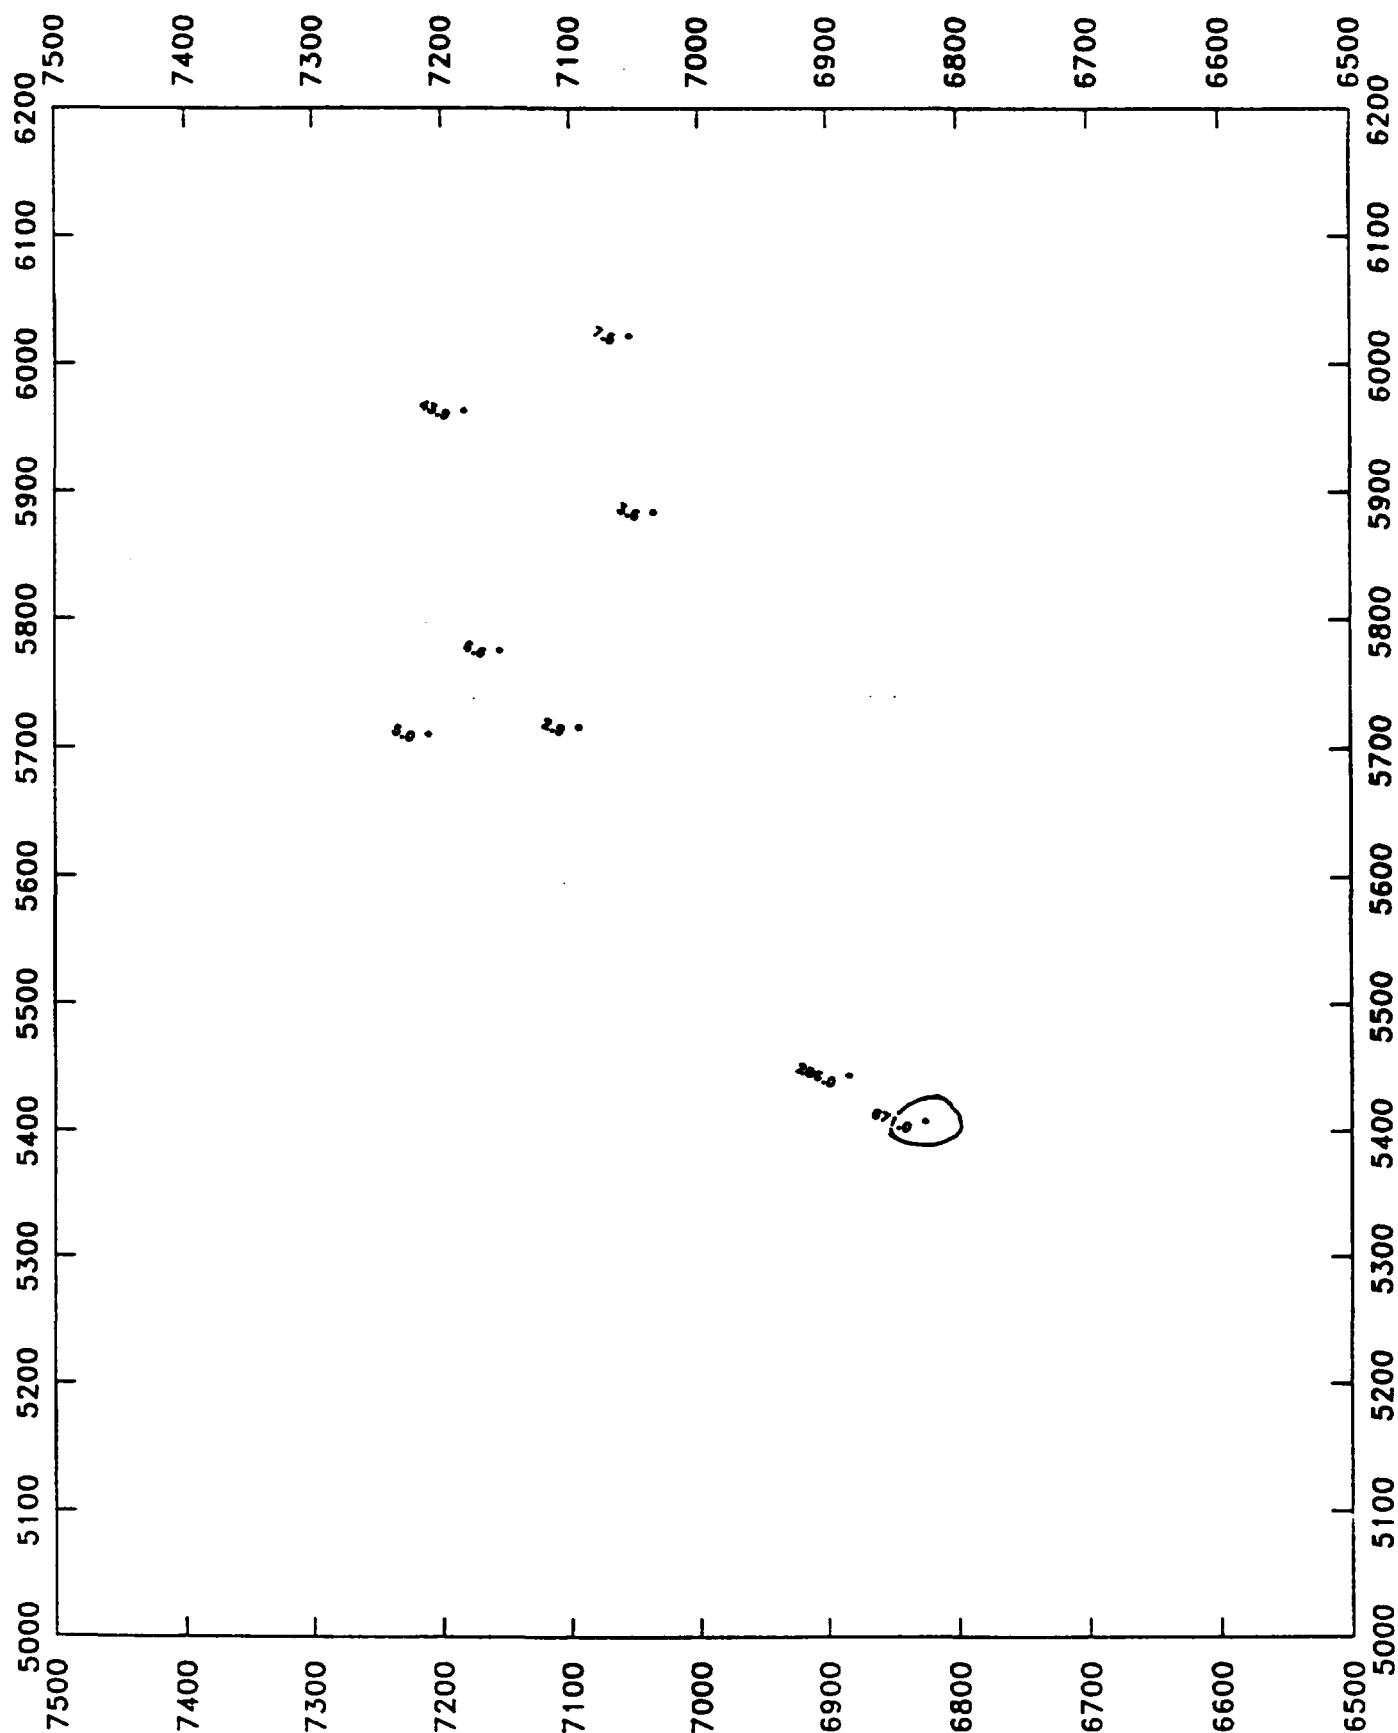
Figure 5-8c Approximate Extent of Lead Containing Wastes (> 500 ppm), On-Site Areas (7-10 feet below surface). Posted Values are in ppm (mg/kg).
